PASSAIC RIVER BASIN
TROY BROOK, MORRIS COUNTY
NEW JERSEY

BIRCHWOOD LAKE DAM

NJ 00168

PHASE 1 INSPECTION REPORT
NATIONAL DAM SAFETY PROGRAM

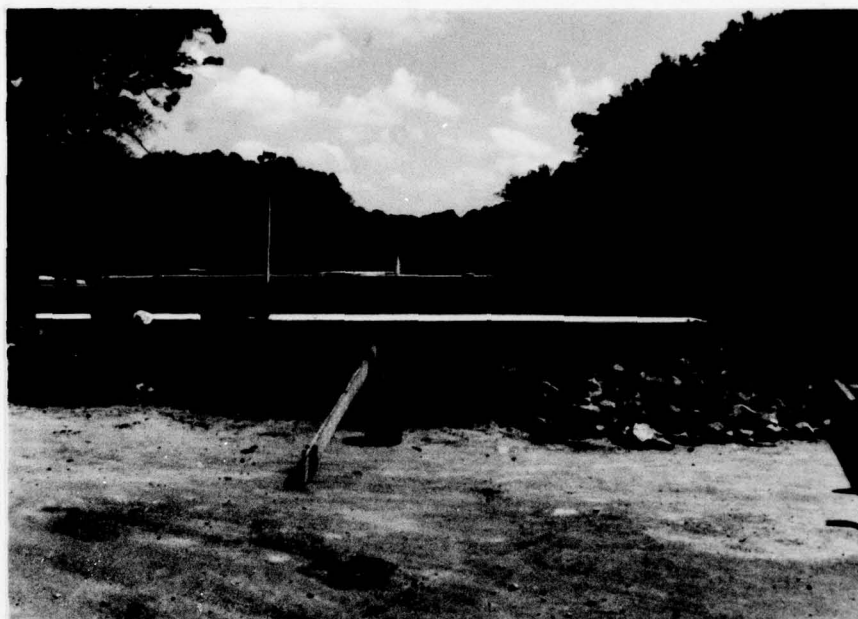
VIEW OF BIRCHWOOD LAKE LOOKING NORTH FROM CREST

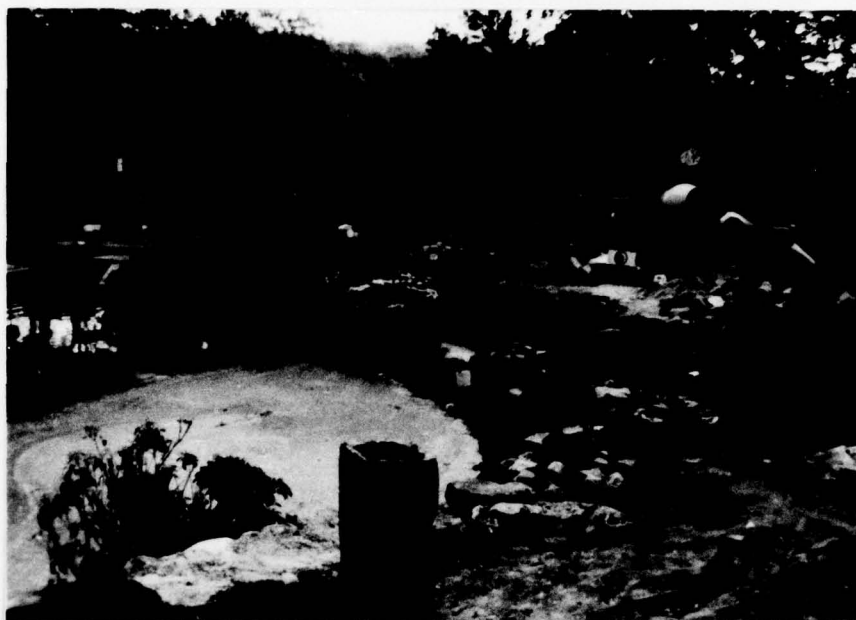
RECONSTRUCTION OF STONE WALL ALONG SOUTH END OF
RESERVOIR ADJACENT TO SPILLWAY INLET
